# Conservation Area Appraisals in the Yorkshire Dales National Park Buckden

**YORKSHIRE DALES**  
National Park Authority

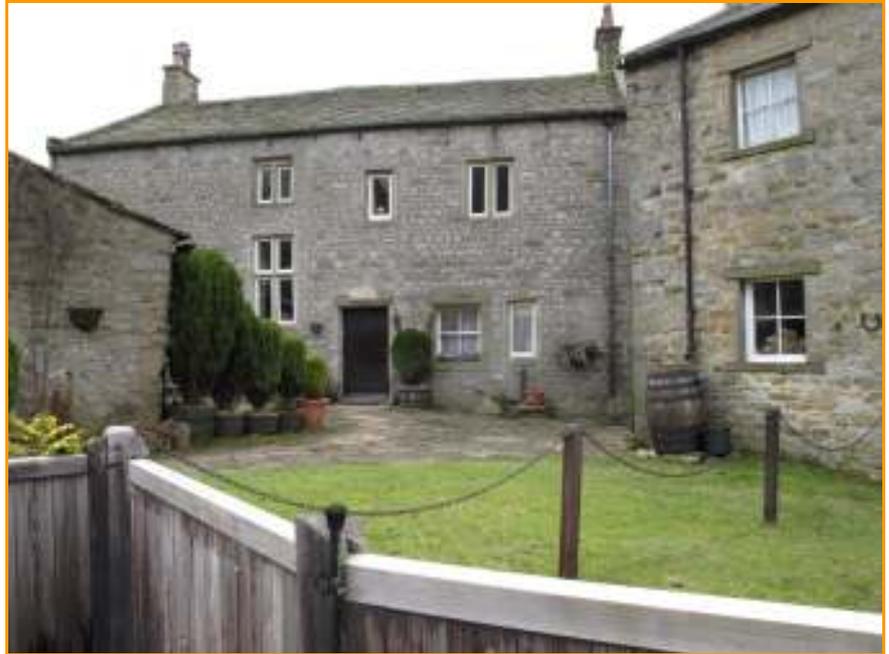
**Figure 07:** Manor House. (photo © Richard Watts, YDNPA, 2009)

1. Manor House - This is a grade II listed building, originally dating from the late 17<sup>th</sup> and early 18<sup>th</sup> centuries. Constructed mainly of coursed limestone rubble, the building features chamfered mullion windows and a graduated stone slate roof.

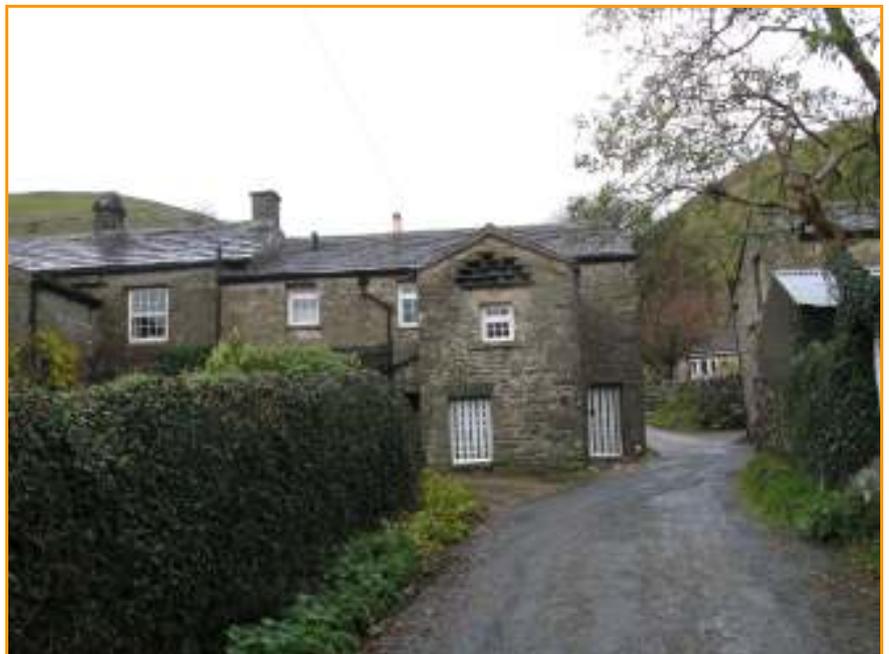
**Figure 08:** Ivy Cottage. (photo © Richard Watts, YDNPA, 2009)

2. Ivy Cottage – This very attractive house, dated to 1705, includes some later 18<sup>th</sup> century alterations. It is grade II listed and is constructed mainly of limestone rubble with a graduated stone slate roof. The building also features a particularly fine example of a dovescote in the roofspace of the southernmost porch. The majority of the windows are traditional sash windows, with chamfered dressed stone surrounds.

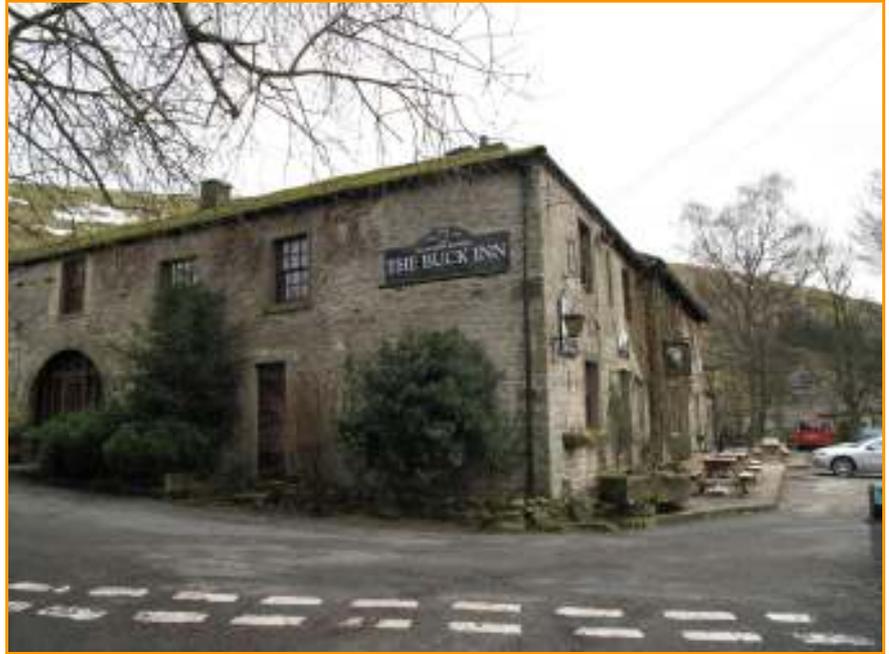
**Figure 09:** The Buck Inn. (photo © Richard Watts, YDNPA, 2009)

3. The Buck Inn – This grade II listed Inn dates from the early to mid 19<sup>th</sup> century, and is mainly constructed of coursed squared gritstone, with a grey slate roof. The windows are traditional timber sash windows, with simple plain stone lintels and surrounds. The building has some considerable later alterations and extensions, though these are built in keeping with the style of the original structure.

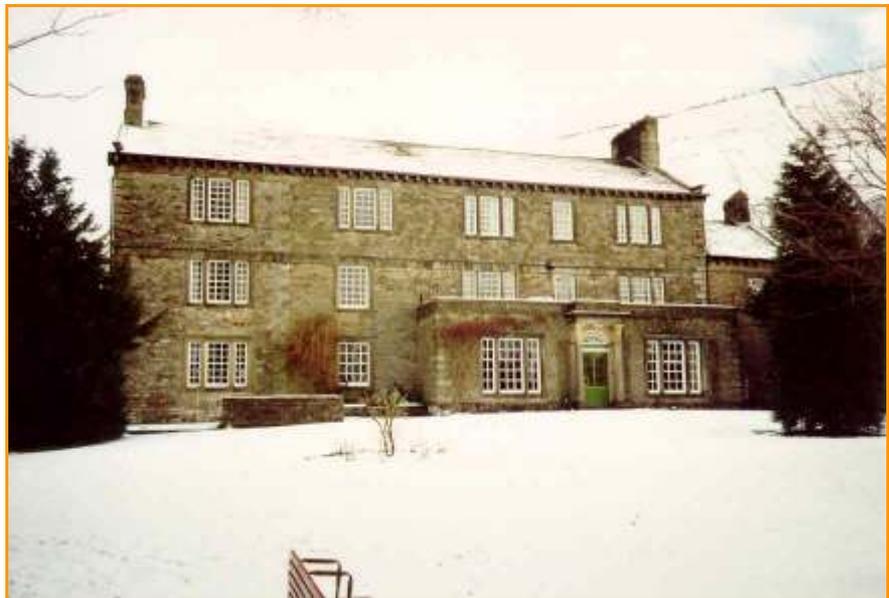
**Figure 10:** Buckden House. (photo © YDNPA, 1997)

4. Buckden House – This large house is grade II listed, and dates from the mid 18<sup>th</sup> century, though includes some 19<sup>th</sup> century extensions and alterations. The building is constructed of coursed squared gritstone and features a graduated stone slate roof. The building has some nice architectural features, particularly a fine array of windows, and represents the more historically ornamental face of the village. The windows are traditional timber sash, and many have plain mullions separating the sashes. The layout of the windows is unusual though, as there is a distinct asymmetry in the size of windows used, which serves to give the building an intriguing facade. The large extension on the south-western elevation, featuring the columned porch, is a later addition however.

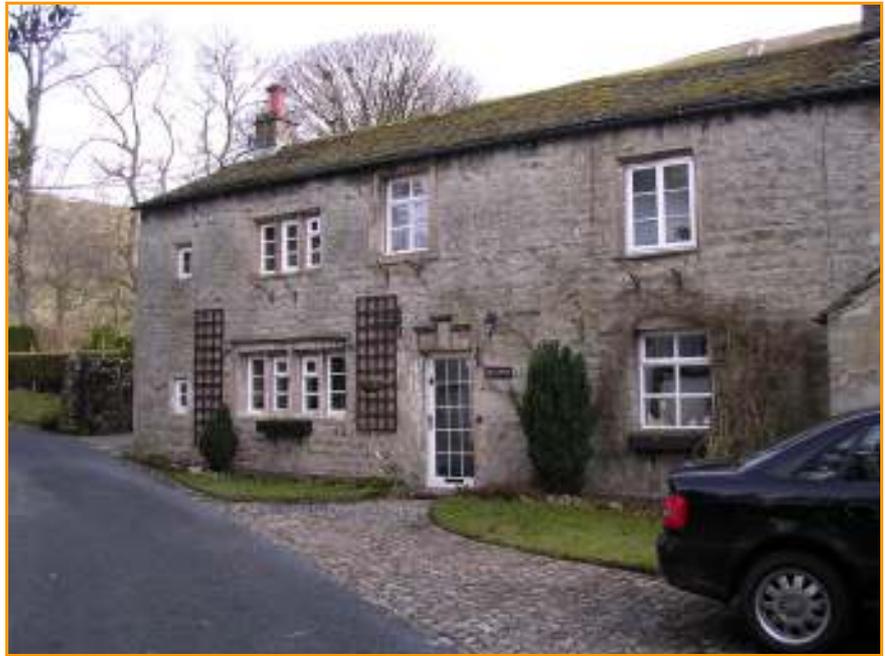
**Figure 11:** Mullions. (photo © Richard Watts, YDNPA, 2010)

5. Mullions – This is rather a small house, dating to the 17<sup>th</sup> century, and is grade II listed. It is constructed of limestone rubble, with a graduated stone slate roof. The building features a mixture of mullioned and sash windows.

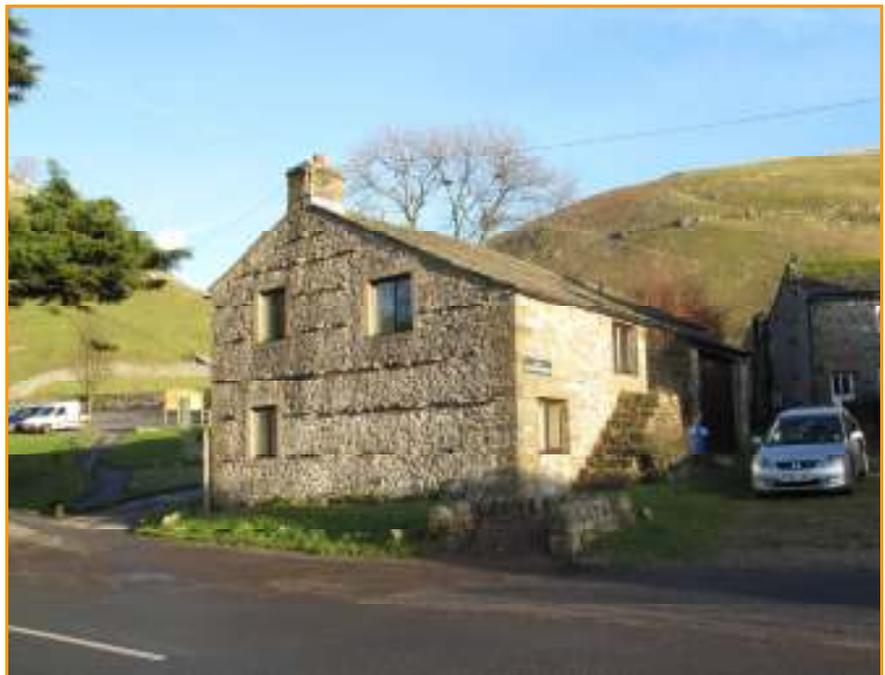
**Figure 12:** Town Head Barn. (photo © Richard Watts, YDNPA, 2009)

6. Town Head Barn – Recently restored by the National Trust, this building represents one of the better barn conversions within the conservation area, retaining many of its original features. It is constructed of coursed limestone rubble with particularly prominent through stones, and features

a sandstone slate roof. The barn features an intriguing set of external steps, that lead up to a blocked doorway on the southern elevation, which has now been replaced with a window.

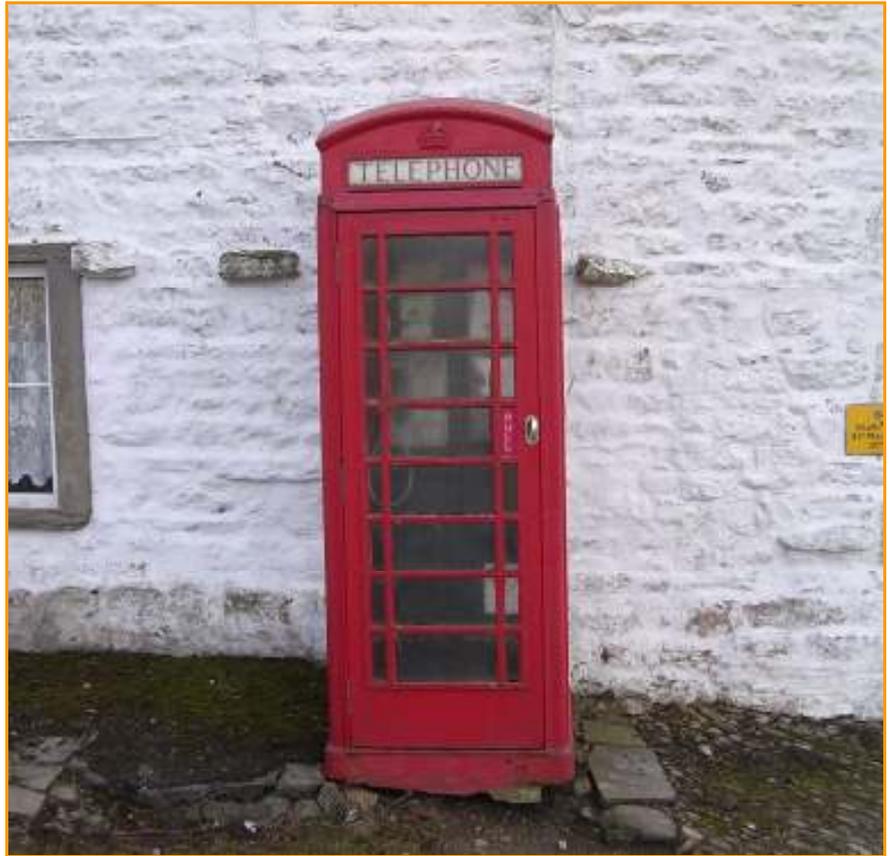
**Figure 13:** Phone Box. (photo © Richard Watts, YDNPA, 2010)

7. Phone Box – This is an early style of phone box, of the K6 designation which is becoming increasingly rare, and which adds to the historical interest of the village.

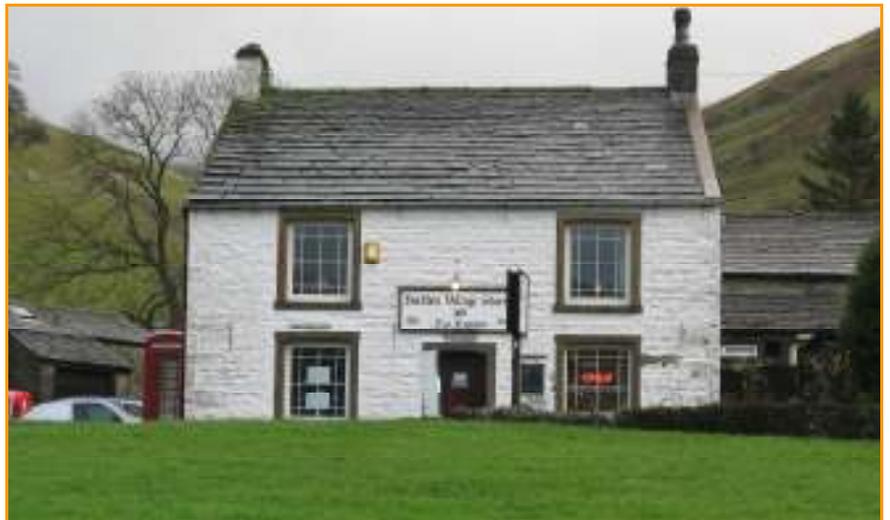
**Figure 14:** Buckden Village Store. (photo © Richard Watts, YDNPA, 2009)

8. Buckden Village Store – This is a typical Dales country farmhouse, now converted to a shop. It is built of coursed limestone blocks, and still features the lime whitewashing that would have been more prominent throughout the Dales. The uPVC windows, featuring fake glazing bars detract from the appearance of the building. The internal neon sign is another detractor

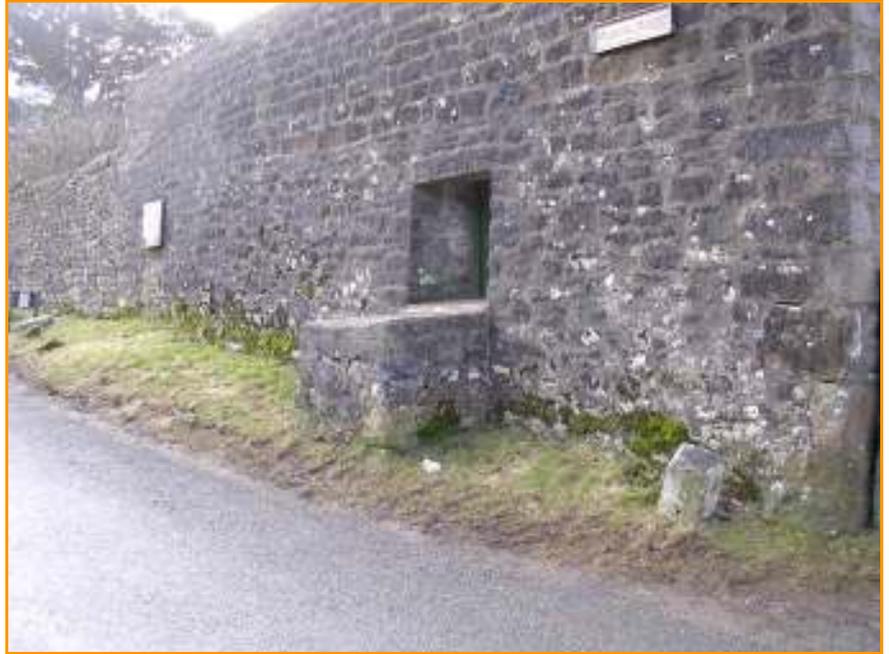
**Figure 15:** Churn Stand outside the Manor House. (photo © Richard Watts, YDNPA, 2010)

**9 & 10.** Churn Stands – These are roadside platforms, dating from the late 19<sup>th</sup> and early 20<sup>th</sup> centuries, built to allow easy loading of milk churns onto carts and trucks. The sight of full milk churns awaiting collection would have been common along Dales roads, and these functional structures provide another attractive link to the village’s agricultural past. The illustrated example is particularly unusual, in that it was loaded from behind the wall, through the small hatch.

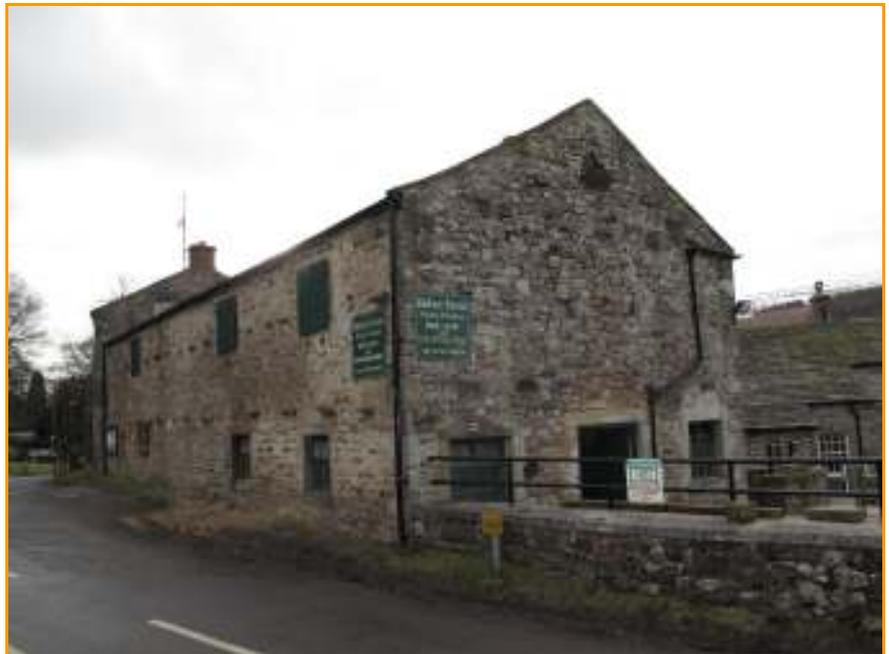
**Figure 16:** Heber Farm. (photo © Richard Watts, YDNPA, 2009)

**11.** Heber Farm – This is another example of a very well preserved building, constructed from uncoursed limestone rubble, and with prominent through stones on the roadside elevation. The building is still in agricultural use, and provides a very attractive physical link to the farming past of the village.

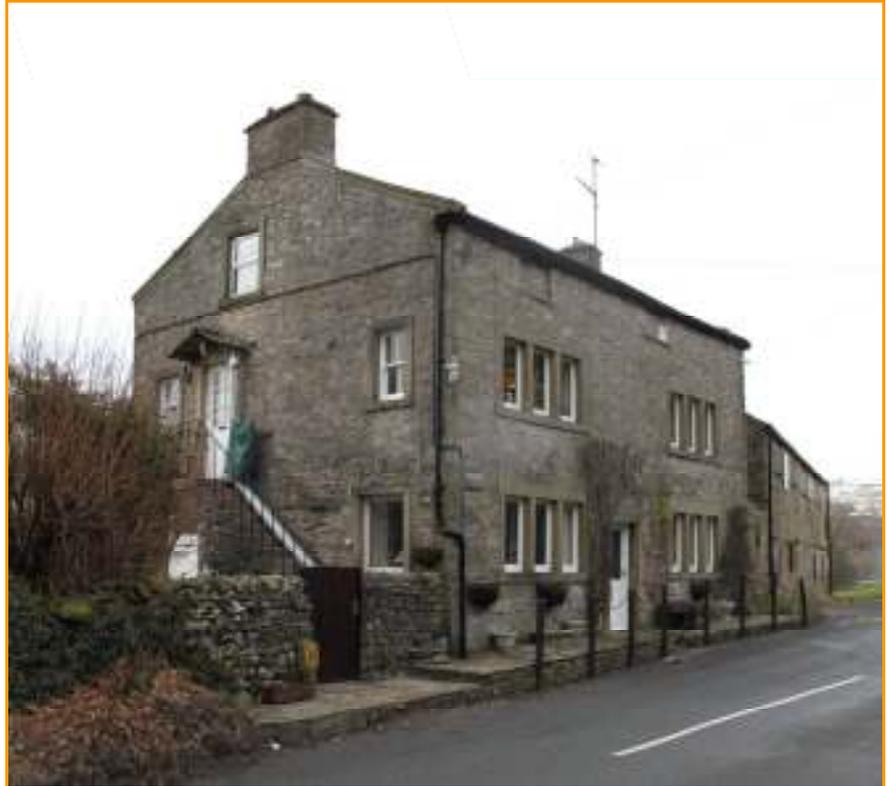
**Figure 17:** Greystones. (photo © Richard Watts, YDNPA, 2009)

12. Greystones – This is a large house, constructed in the mid 18<sup>th</sup> century, using sandstone and limestone rubble, and with a stone slate roof. The house is of three storeys, though the upper windows on the front elevation have been blocked. The property has a modern extension discretely tucked away behind the main building. The building may have possibly been used historically as a wool store.

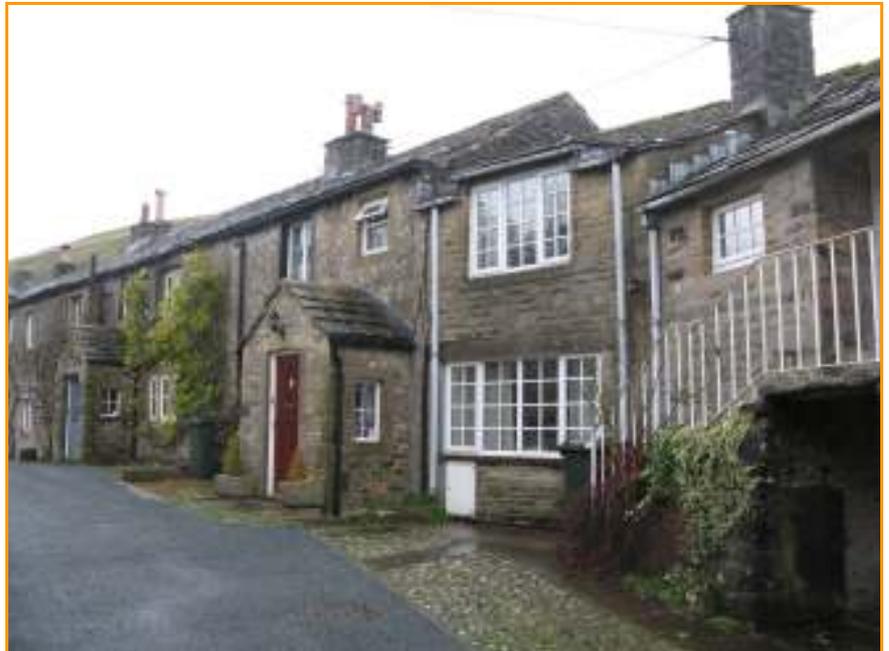
**Figure 18:** Row of Cottages. (photo © Richard Watts, YDNPA, 2009)

13. Row of Cottages – This is a group of terraced cottages, typical of the accommodation probably built to house the estate and industrial workers. The attractiveness of the group is quite seriously marred however by the introduction of uPVC windows and the mixed use of plastic rainwater goods and lightweight railings to several properties. The replacement of these very visually detracting features with more authentic materials would be a major improvement to the appearance of the conservation area.

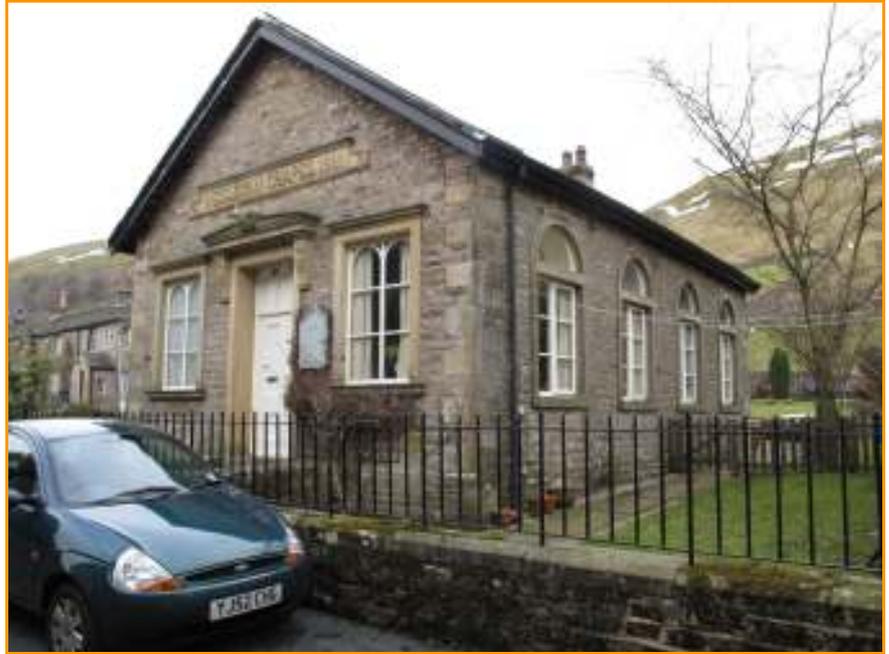
**Figure 19:** The Wesleyan Chapel. (photo © Richard Watts, YDNPA, 2009)

14. The Wesleyan Chapel – This former Methodist chapel is dated to 1891, and is built of coursed limestone blocks. It features ashlar quoin stones and window surrounds, with a stone slate roof. It is no longer in religious use, and has been converted into holiday cottages.

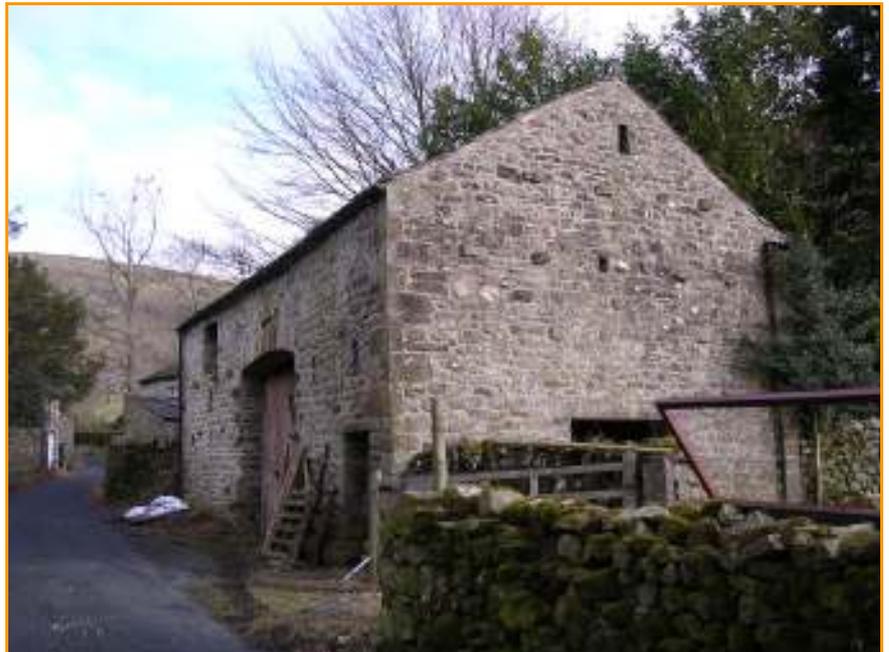
**Figure 20:** Barn used for Agricultural Storage. (photo © Richard Watts, YDNPA, 2010)

15. Barn used for agricultural storage – This is a traditionally built Dales farm building, still used to store agricultural equipment. The building features a large cart entrance door on the west elevation, which would suggest a prior use as a cart shed. Constructed of uncoursed limestone rubble, with a stone slate roof, and large quoin stones, the building appears to be in a very good state of preservation. Regular maintenance checks are vital in ensuring that buildings like this remain in good condition, and can continue to serve a useful function.

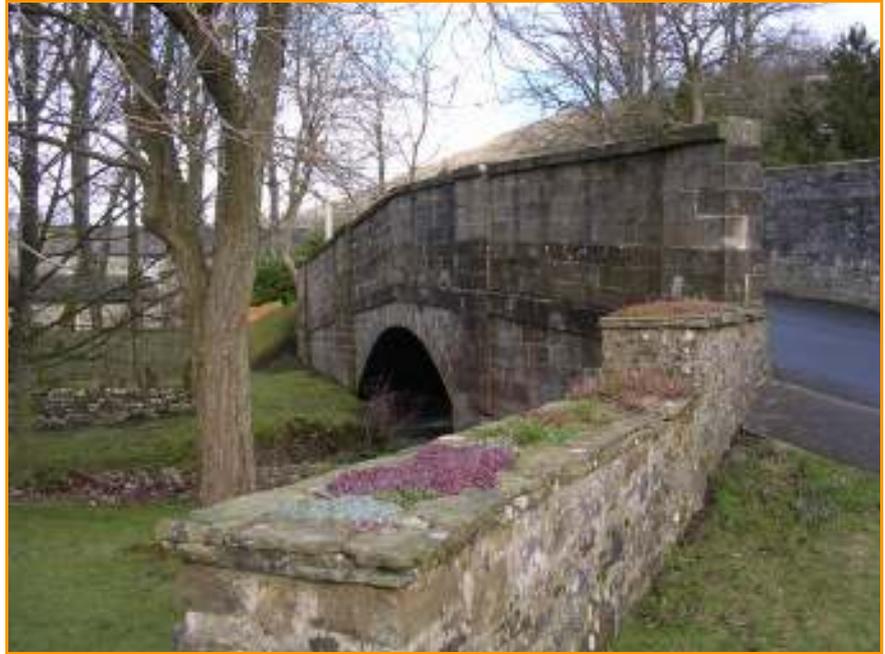
**Figure 21:** Buckden Beck Bridge. (photo © Richard Watts, YDNPA, 2010)

16. Buckden Beck Bridge – This is a rather simple construction of dressed limestone blocks, and carries the main road through the village over Buckden Beck. It was very much built as a utilitarian structure, and has little in the way of ornamentation, other than a simple coping layer, though the use of ashlar stones in its construction is quite unusual. The parapet walls are also unusually high, and appear to have been raised at some point; this is most likely the result of a desire for extra privacy by the owners of Buckden House.

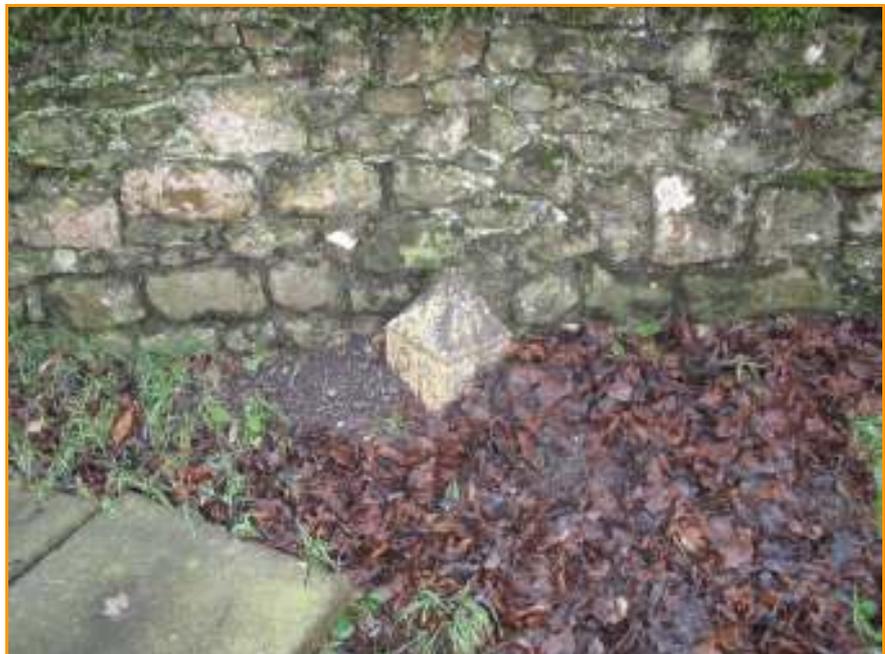
**Figure 22:** Bridge Liability Marker. (photo © Richard Watts, YDNPA, 2009)

17. Bridge Liability Marker – This is a small, cast iron post, marking where responsibility for maintenance of the bridge and its carriageway began and ended. It likely dates to the late 19<sup>th</sup> century, and is inscribed WR, for the West Riding of Yorkshire County Council, indicating that they were the body responsible for the upkeep of the bridge. Normally, a pair of markers would have been used, but unfortunately, the marker on the southern side of the bridge has been lost.

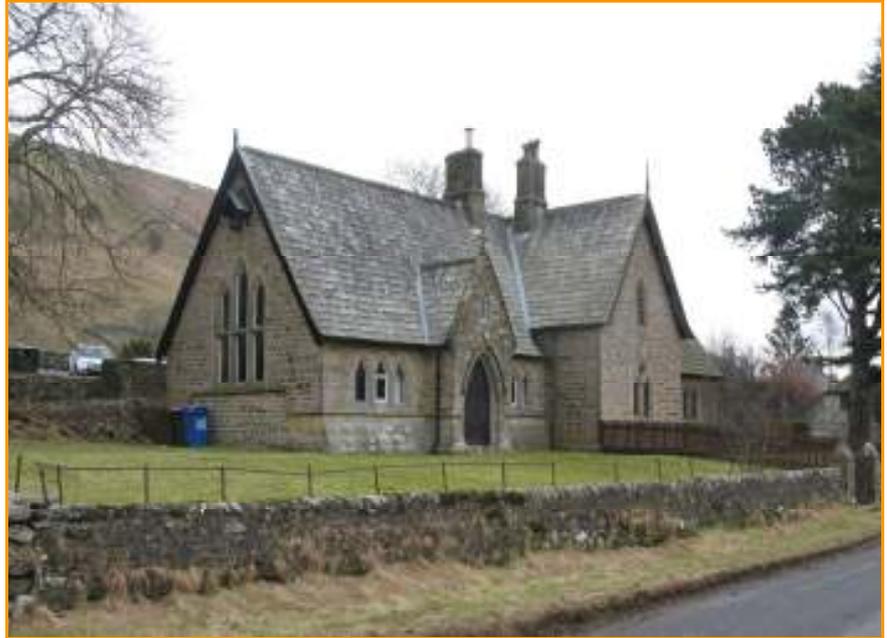
**Figure 23:** The Schoolhouse.  
(photo © Robert White, YDNPA,  
2010)

18. The Schoolhouse – Built in the mid Victorian mock Gothic style, the Schoolhouse was organised and paid for locally, and opened in 1857. It is constructed of coursed limestone blocks, with ashlar quoin stones and features some very attractive pointed arch windows. The roof is of Westmorland slate and is at an unusually steep pitch. Several large, mature trees can be found in the grounds, as can the former outhouses, both of which are still intact. The Schoolhouse closed in 1933, and has since been divided into two halves; one half has been converted to a private residence, whilst the other is now used for Parish council functions. Whilst the Schoolhouse was not included within the 1969 Conservation Area boundary, it is now considered that it makes a significantly positive contribution to the character of the village, being particularly visible as one enters the village from the north, and thus warrants inclusion.

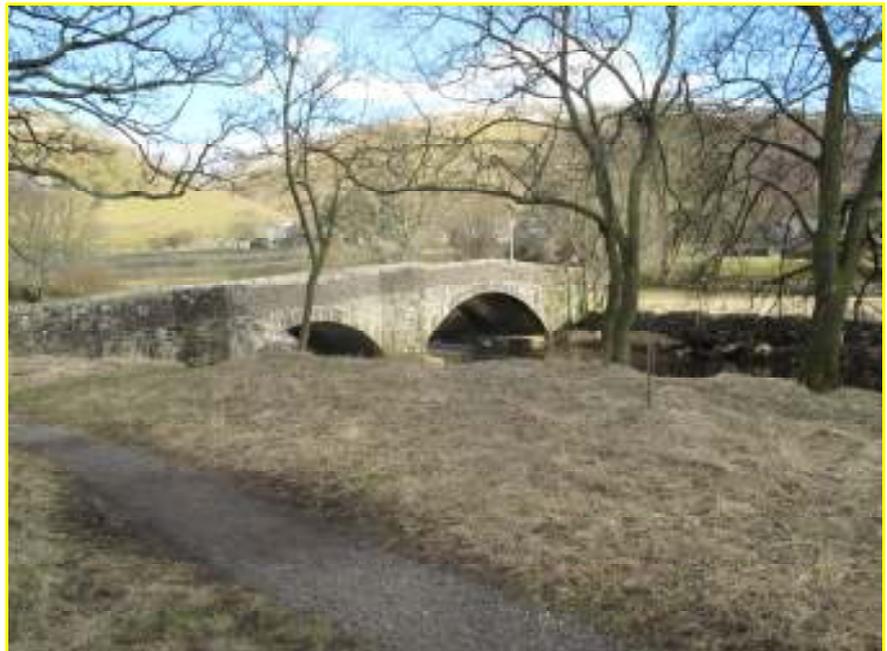
**Figure 24:** Buckden Bridge  
(photo © Richard Watts,  
YDNPA, 2010)

Buckden Bridge is a grade II listed building, and is situated to the north-west of the village, on the road from Hubberholme to Buckden. It is constructed of limestone rubble with ashlar quoins and a coursed, hammer-dressed gritstone parapet. The bridge shows clear evidence of having

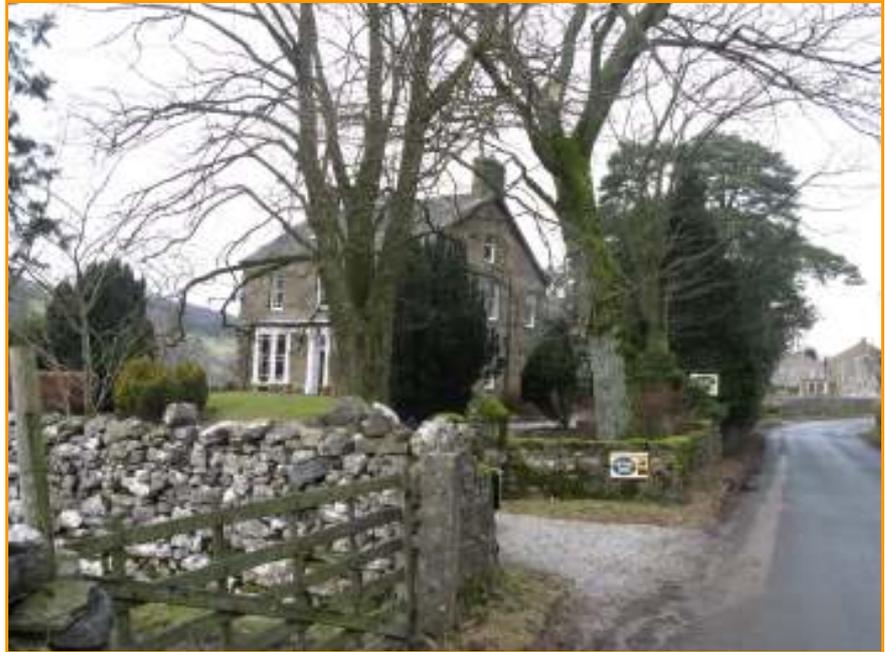
**Figure 25:** Hartrigg House  
(photo © Robert White, YDNPA, 2010)

One final structure worthy of note is the building now known as Hartrigg House. This is a fine Victorian structure, located on the southern edge of the village. It is constructed of coursed, dressed limestone blocks, with prominent ashlar quoin stones and with many fine traditional timber sash windows. The grounds of the house also include many attractive mature trees. The building has an impressive appearance as one enters the village from the south, and has quite an imposing character. Unfortunately, the building is some distance from the current conservation area boundary, and the intervening structures are not of sufficient character to warrant inclusion, having been quite unsympathetically altered, and so the extension of the conservation area boundary to include this building is not considered justified.

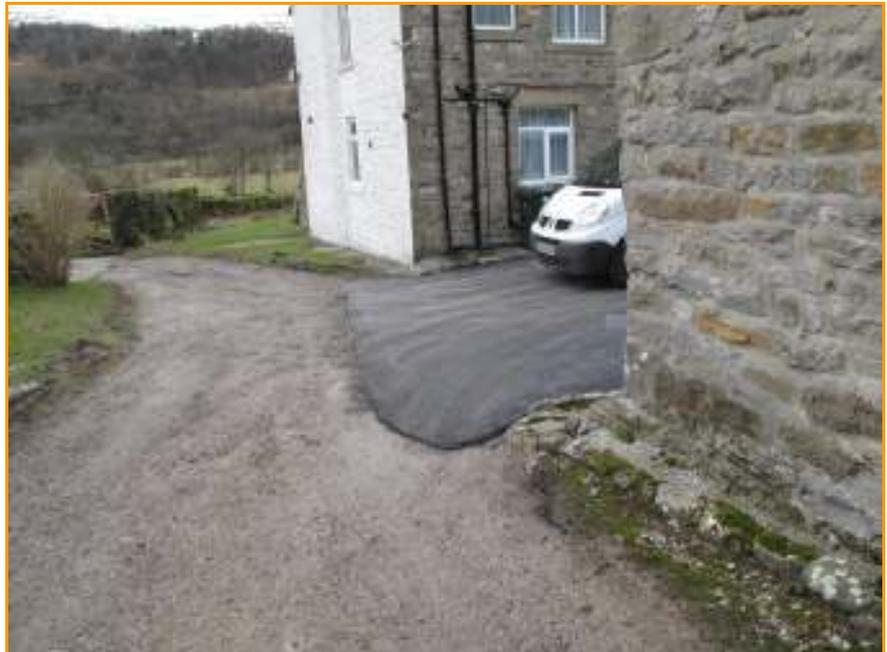
The windows in the conservation area would originally have been in timber, in a traditional sash or casement style, though unfortunately, a large proportion of these have been replaced with uPVC windows. Several buildings feature mullioned windows, though these are usually of a simple dressed stone. Drystone walls also contribute to large areas of the conservation area, particularly on the fringes, where the land use changes to agricultural enclosures. Road surfaces within the conservation area are generally of tarmac, though some of the older gravel trackways and drives still survive, and add considerably to the charm of the village. Whilst the need for maintenance and repair of these trackways is appreciated, the increasing tendency to tarmac over these surfaces can have quite a negative effect upon the setting of the local buildings (see figure 26).

**Figure 26:** Unsympathetic Road Resurfacing. (photo © Richard Watts, YDNPA, 2009)

The choice of materials used in resurfacing works should be carefully considered in order to avoid damaging the setting and appearance of the associated buildings.

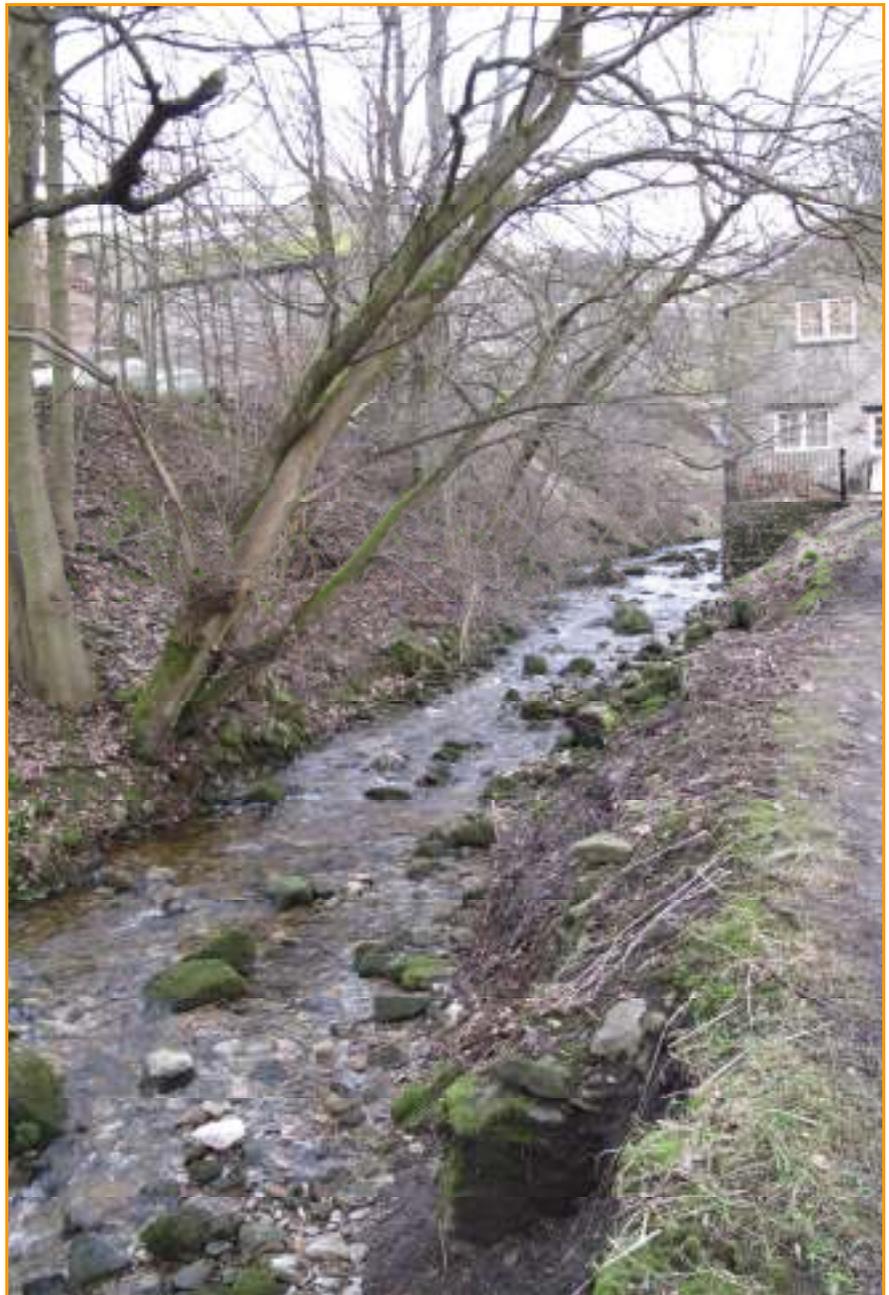
**Figure 27:** Buckden Beck.  
(photo © Richard Watts,  
YDNPA, 2009)

Perhaps the most important contribution to the character of the conservation area though comes from Buckden Beck. Rivers and streams are a UK Biodiversity Action Plan (BAP) priority habitat. The stream flows through the heart of the village, effectively cutting the settlement in half, before flowing into the River Wharfe, just outside the conservation area. Whilst not always immediately visible, the Beck is very picturesque, especially where it rises out of the conservation area, up towards Buckden Pike. The northern bank features many small trees, which, in addition to being very attractive, also serve to hold the bank together and reduce erosion into the watercourse. The southern bank has no such trees and has eroded slightly in some parts; this situation needs to be monitored, and if necessary, action should be taken to maintain the bank.

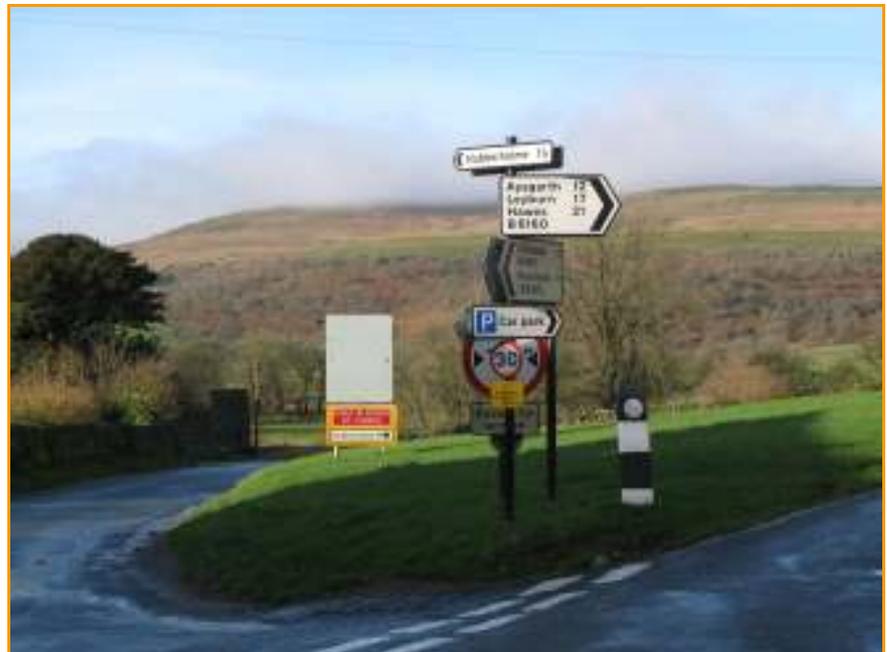
**Figure 28:** Road Signage on the Village Green. (photo © Richard Watts, YDNPA, 2009)

1. The road signage on the village green (see figure 28). The sheer amount of information that is presented here is overwhelming, not to mention unnecessary, as much is simply repetition of other road signs located within a very short distance. The rationalisation of this signage, to include only the information truly needed to inform motorists, would be a considerable improvement to the appearance of the village green.

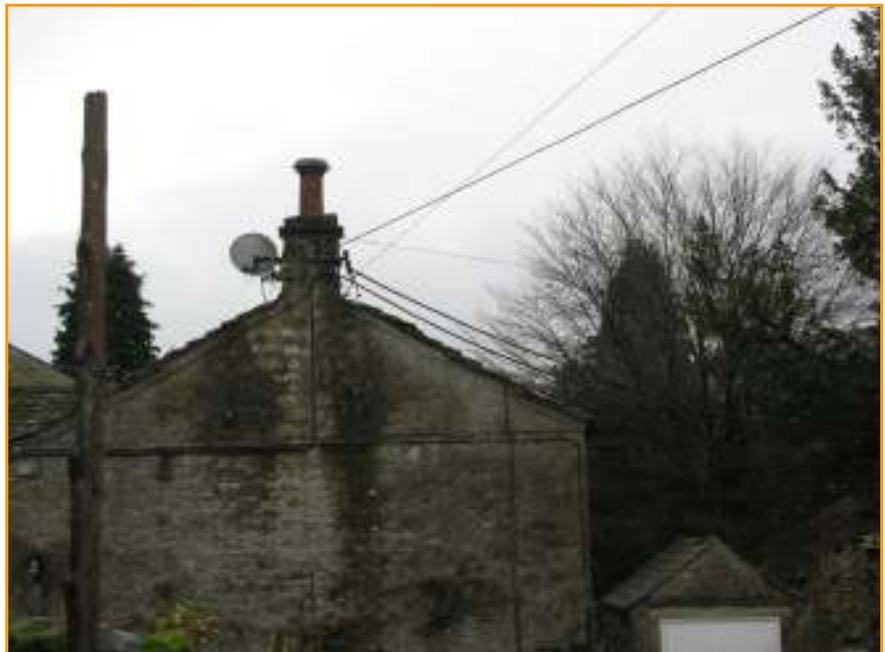
**Figure 29:** Overhead Wiring. (photo © Richard Watts, YDNPA, 2009)

7. The presence of a significant amount of overhead wiring is a highly visible intrusion on the character of the settlement (see figure 29). Whilst the provision of services should not be compromised, a significant amount of the wiring could probably be undergrounded, or at least rationalised into a less intrusive pattern.

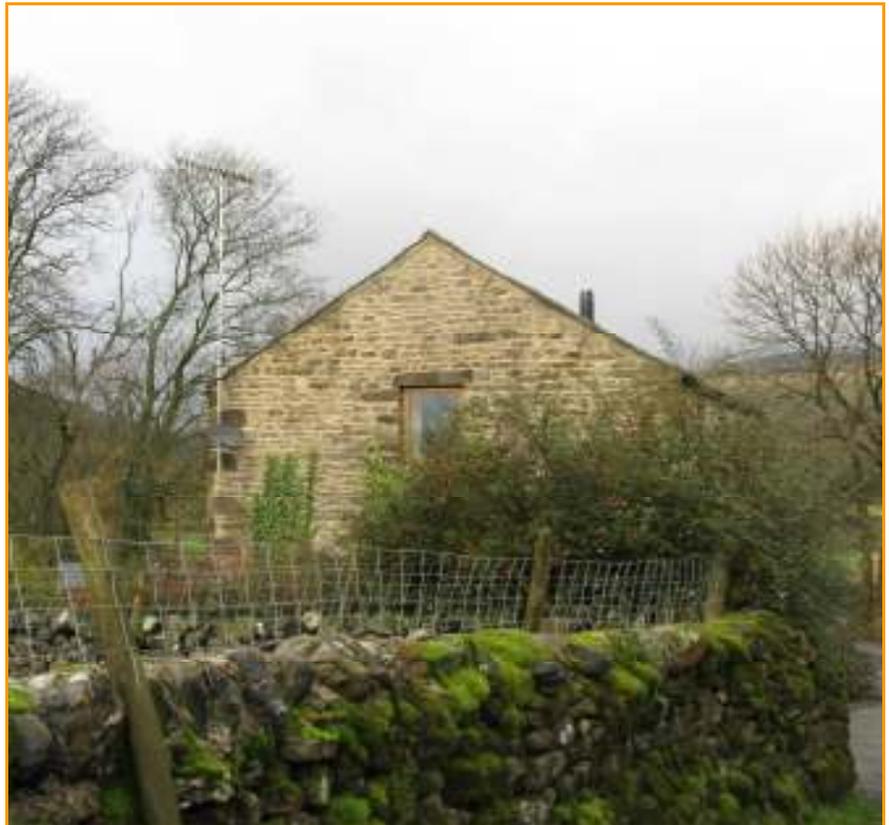
8. Many of the structures within the conservation area feature very prominent television aerials (see figure 30). Whilst appreciating the obvious desire for good quality reception, these structures do distract the attention from some otherwise very attractive buildings. These features are often quite mobile and transient, and a positive contribution to the quality of the conservation area could be made if these highly visible structures could

**Figure 30:** Prominent Television Aerial. (photo © Richard Watts, YDNPA, 2009)

be replaced, or re-sited to more discrete locations, without compromising the quality of service, particularly in light of the imminent digital switch-over and continuing technological improvements.

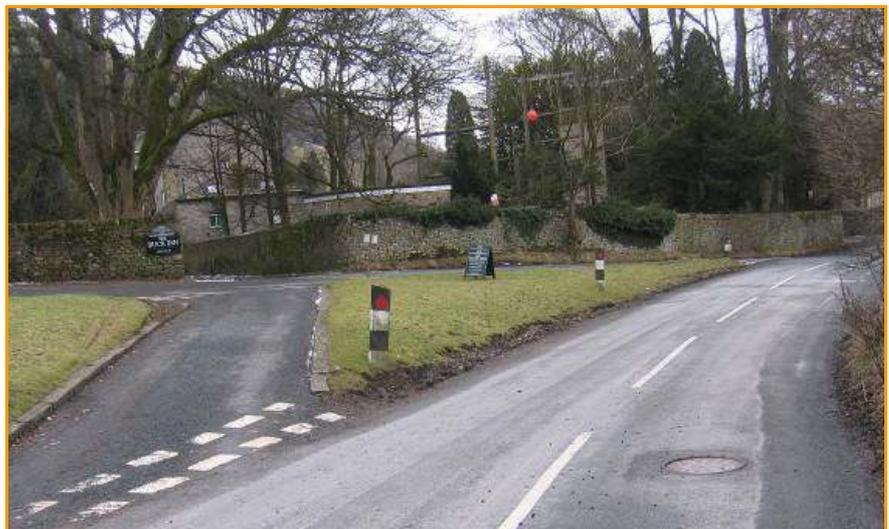
9. The village greens provide valuable open space within the village; however, some edges are being eroded away due to vehicles running over the edges (see figure 31). This action serves to reduce the size and appearance of these areas, especially when repairs to the highway are conducted and the eroded areas are covered in tarmac. One possible solution would be to continue the stone kerbing already present on some edges of the greens, and reseed the bare patches with grass. This would provide a physical barrier to further erosion and would help improve the appearance of the open areas, though would introduce a more suburban character to the green.

**Figure 31:** Eroded Village Green Edges. (photo © Andy Ryland, YDNPA, 2010)

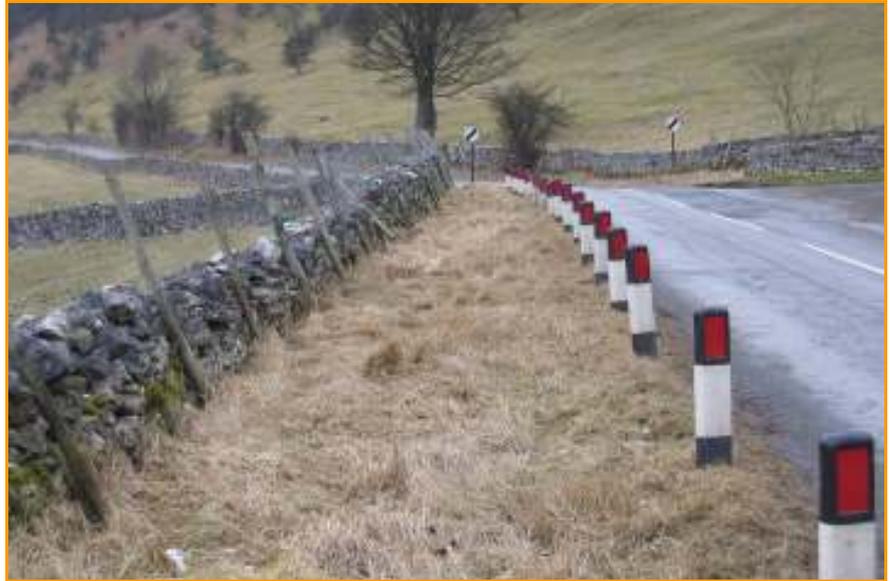
10. The line of plastic reflector poles, located on the northern approach road to Buckden, is a very visual detractor to the entrance of the conservation area (see figure 32). The poles were installed to prevent car park-

**Figure 32:** Plastic Reflector Poles. (photo © Andy Ryland, YDNPA, 2010)

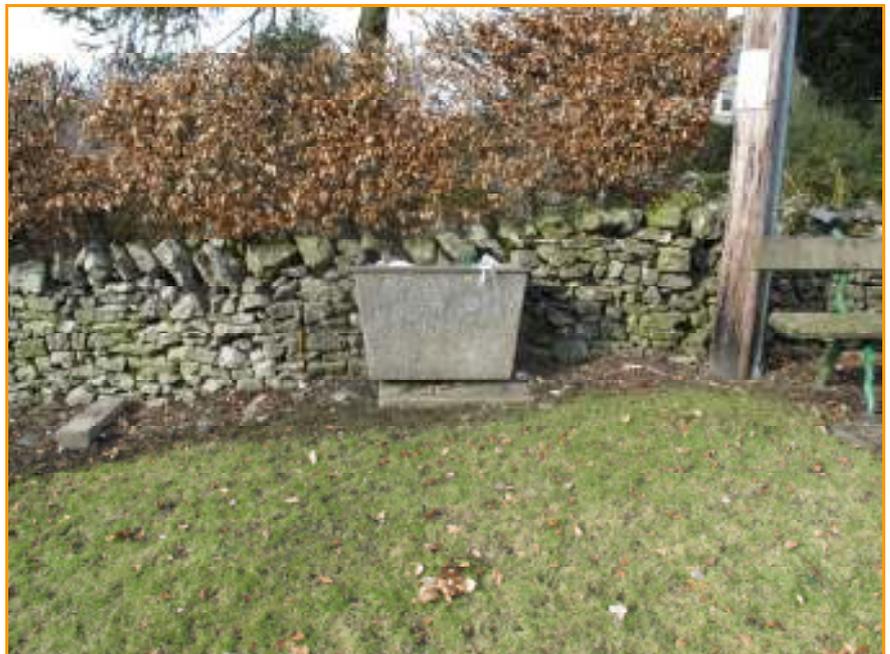
11. The concrete bin, located on the small green outside the Buck Inn is particularly unattractive (see figure 33). Replacing the bin with a more appropriate model would enhance the appearance of the conservation area.

**Figure 33:** Unattractive Concrete Bin. (photo © Richard Watts, YDNPA, 2010)

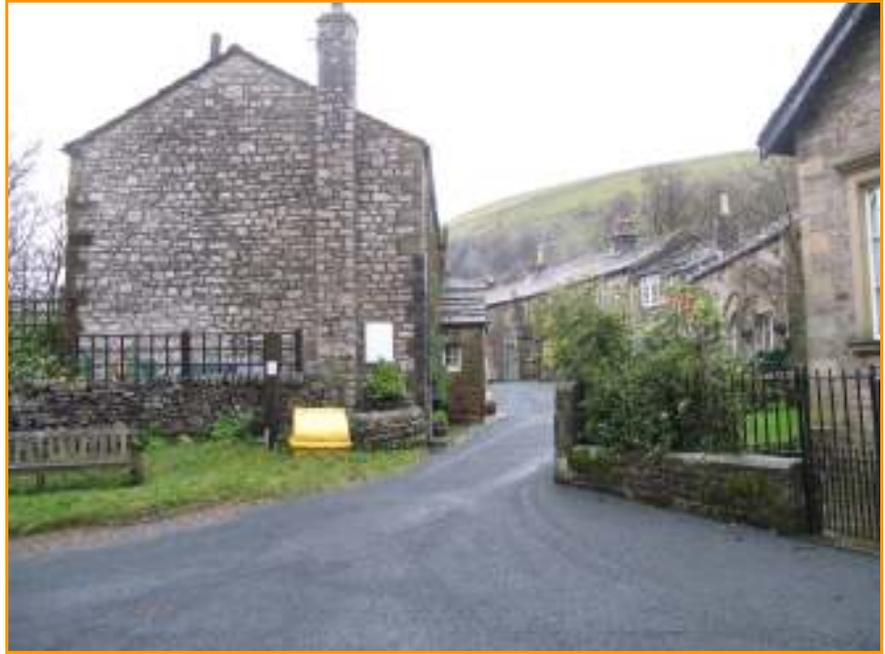
12. The salt bin, located at the end of the narrow lane, behind Buckden House, is coloured in a particularly vivid yellow, and is highly intrusive (see figure 34). The construction of a small, purpose built stone structure to house the salt would also enhance the appearance of the conservation area.

**Figure 34:** Unattractive Salt Bin.  
(photo © Richard Watts,  
YDNPA, 2010)
